NeZeR Design Competition [Spain]

Sustainable Built Environment conference –SBE 16
Tallinn/Helsinki, 5-7 October 2016

Present situation of the building

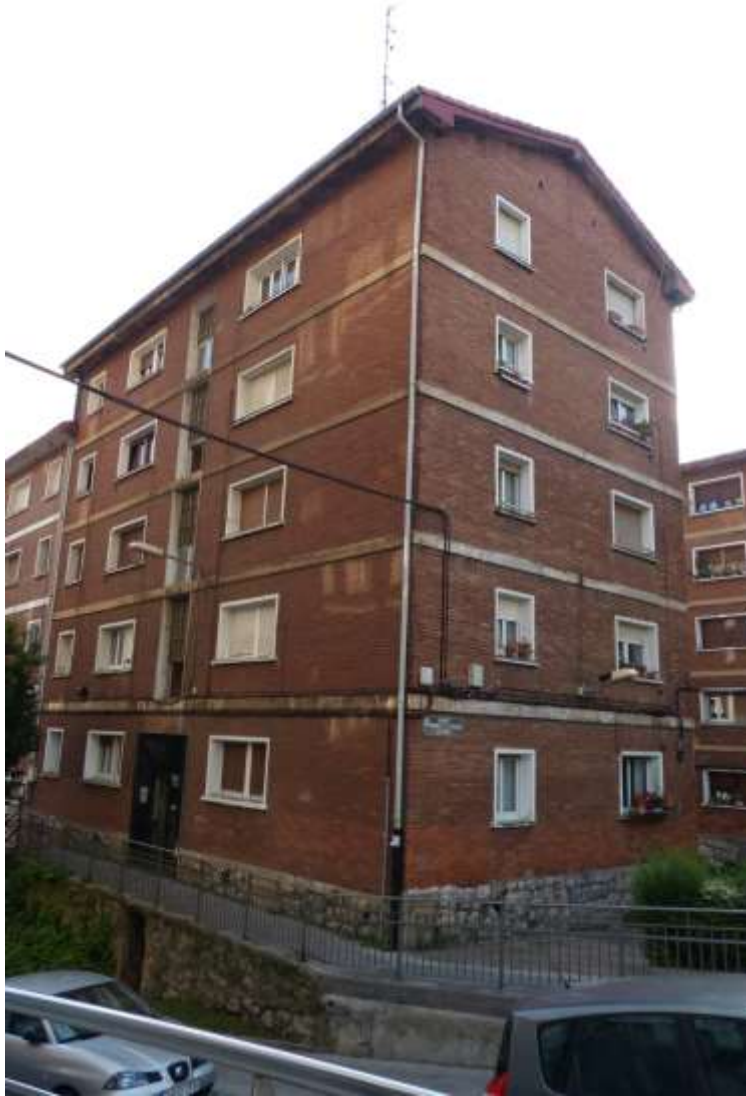
- Multifamily block, 20 dwellings, 1362.15 m²
- Building year: 1967
- No renovation
- Ownership type: private/ Elder users
- 5 floors, 1 basement, brick walls and gabled ceramic roof
- Energy consumption. Individual boilers
 - Space heating 113,8 kWh/m²
 - Domestic hot water 17,1 kWh/m²
- Deficient indoor environment quality
- Neglected facades, electric cables unprotected
- Architectural barriers (no lift)

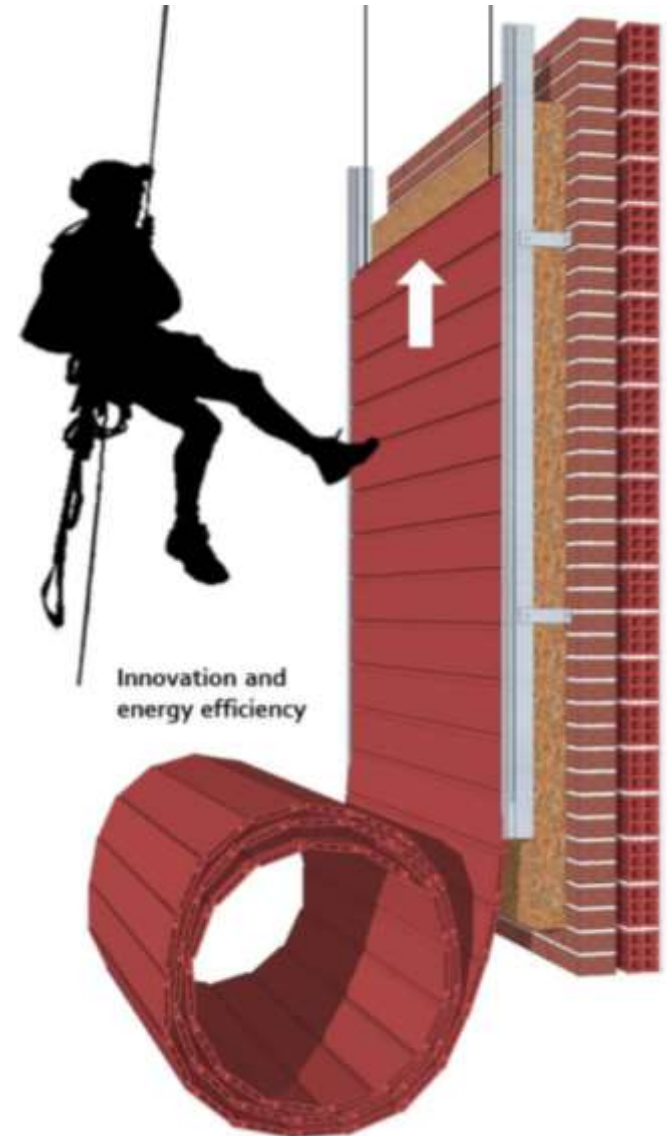
Renovation concept – general

- Envelope improvement, use of renewable energy sources, accessibility and efficient illumination improvement.
- Ambition – energy performance after renovation:
 - Energy consumption:
 - Space heating (48.88 kWh/m²)
 - Domestic hot water (13.65 kWh/m²)
 - Energy performance leap from label E to A
- Building envelope improvements: Ventilated façade with wood fibre insulation
- Changes in HVAC installation: Centralized installation with individual energy efficient monitoring
- Renewable energy technologies: biomass boiler, solar panels
- Accessibility: lift installation, change the central core of the building

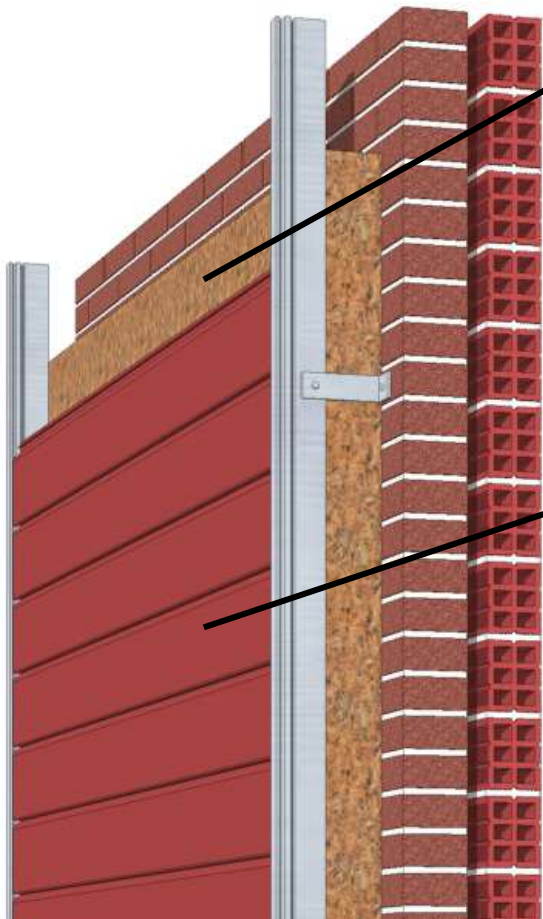
Environmental aspects – Materials selected

- Wood fibre insulation
Wood is a natural, ecological, renewable material and carbon sink. It has excellent thermal and acoustic behaviour. Zero toxicity
- Anodized aluminium
100% recyclable, “cradle to cradle”, easy to transport (light material), durable, low maintenance (corrosion and abrasion resistance) , zero toxicity, “eco-metal”, sustainable.

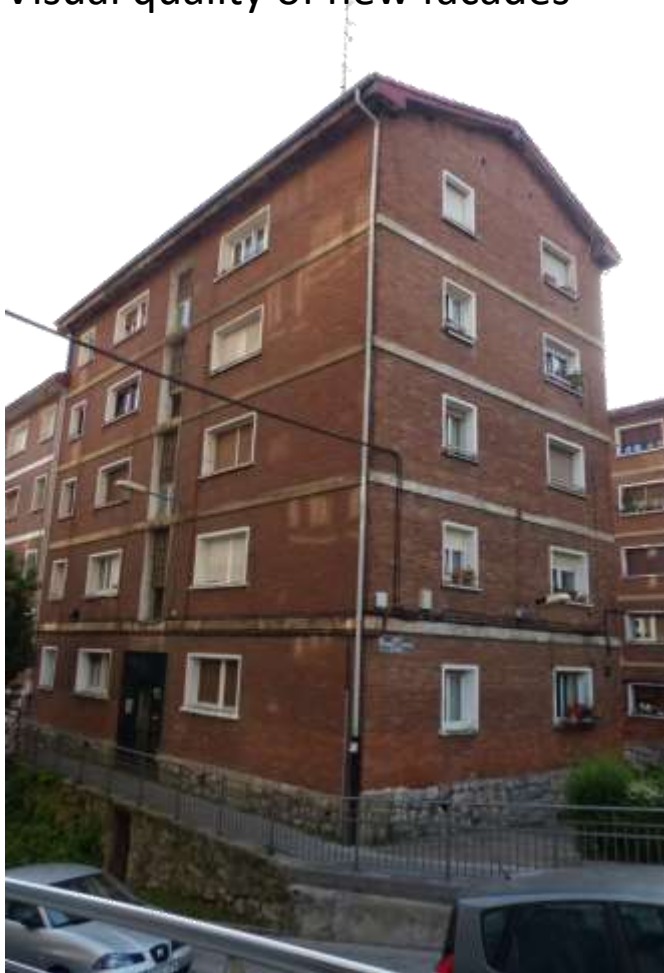
Before

- Visual quality of new facades

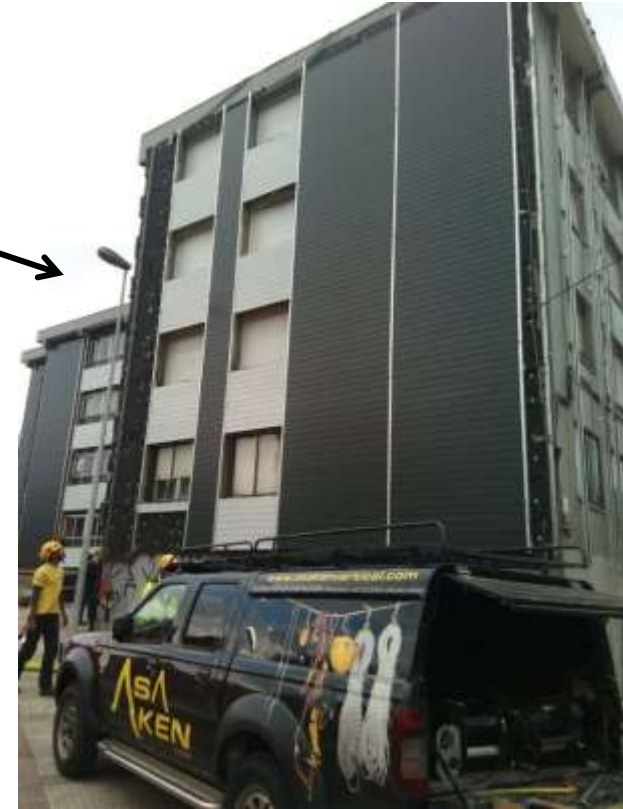
Case study in Urduliz (Spain)

- Replication potential (buildings from 1951 to 1980)
 - 702 buildings in Sestao (60%)
 - 3.410.771 buildings in Spain (35%)
- Proven technologies
 - Case study: Residential building in Urduliz (Spain)
- Engineering solutions – ease of implementation
 - Use of common retrofitting solution (ventilated façade)
 - Easy external cladding assembly
 - No scaffolding
- Technical risks
 - Material cost fluctuation (aluminium)
 - Proven technology without technical risks
- Prospects for scale of volume effects
 - Higher demand implies lower material price
- Financial aspects – life cycle costs
 - Less maintenance and energetic costs (less demand 60%)
 - Grants: Energy efficiency and accessibility
 - Revalorization of housing (use of basement, lifts, aesthetic improvement)
